**Building Number:** 217

**Original Name:** Family Housing with Garage

**Est. Year of Construction:** 1959

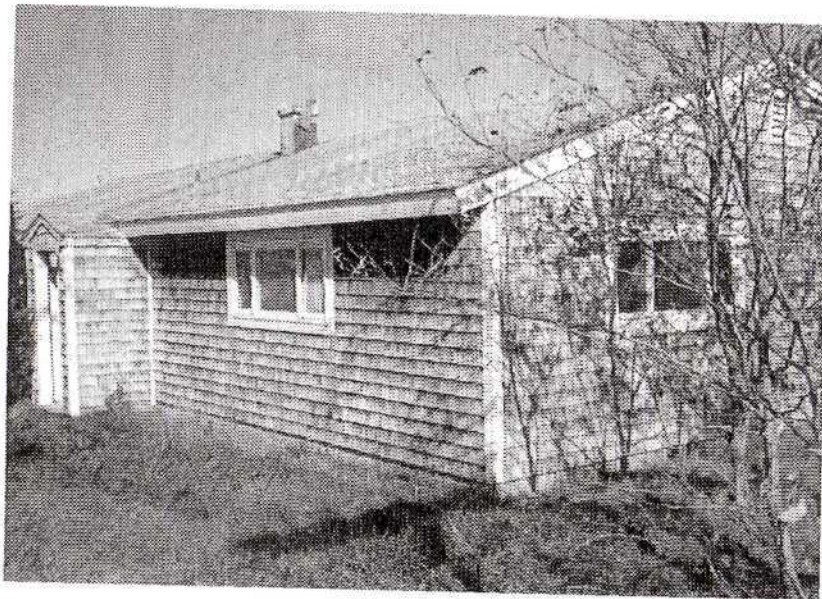
View from southwest.

- *Roof*  
Asphalt shingle roof in **fair condition**. Leak in center over bathroom. Sheet metal chimney painted with brick trompe d'oeil in fair condition.
- *Wall*  
Exterior sheathed in white cedar shingles is in **fair/ poor condition**. Recommend replacement of 150 SF.
- *Trim*  
Painted wood trim in **poor condition**. Needs repair at both porticos (worse in rear) and window trims. Recommend replacement of 60 LF. Soffits in fair condition.
- *Foundation*  
Poured concrete slab on grade in **good condition**.

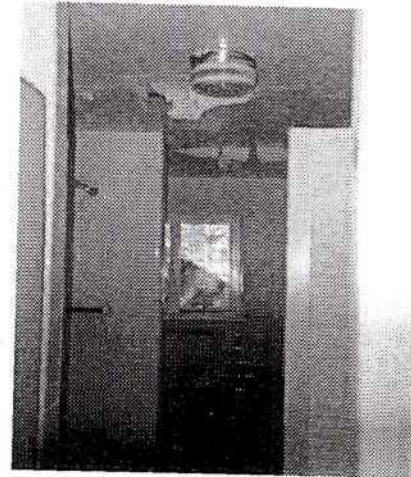
Interior - bathroom.

- *Ceiling*  
Painted drywall in **fair/good condition**. Some mildew damage, minor cracks in drywall and peeling paint. Major leak in bathroom ceiling. Recommend repair and refinishing.
- *Wall*  
Painted drywall in **fair/good condition**. A lot of mildew and some holes. Recommend repair and refinishing. Ceramic tile in bathroom in good condition. Unfinished GWB in garage. Potential workspace at garage (and, possibly, adj. 3<sup>rd</sup> bedroom).
- *Trim*  
Painted slender metal door frames in **fair condition**. Painted wood window and door trim in **fair/good condition**. Tiny baseboards in **fair/good condition**. Some mildew damage. Recommend replacing metal trim and refinishing rest.
- *Floor*  
Sheet vinyl throughout in **fair/good condition**. Floor registers filled with cement. Bathroom tile floor in **good condition**.

Bathroom sinks, tub and shower in fair condition and can be refurbished with new hardware, etc. Code requirements dictate replacement of WC; refer to Mechanical/Electrical/Plumbing section. Kitchen sink in fair condition. Laundry connections non-conforming. Counter space is small. Remove and replace all for fully accessible dwelling unit.

- a) Tub – Install new single handle shower valve (pressure balancing or thermostatic) within the shower with 3 handle to single handle conversion plate. Install new shower head with supply riser. Install new lever waste with overflow kit and drain strainer.
- b) Lavatory – Install new faucet with pop-up drain, new tailpiece, trap and waste connection and new hot/cold water supplies with stops.
- c) Water Closet – Install new 1.6 gallons per flush, floor mounted, tank type water closet with elongated bowl, wax ring, bolts/caps, seat with cover and water supply with stop.

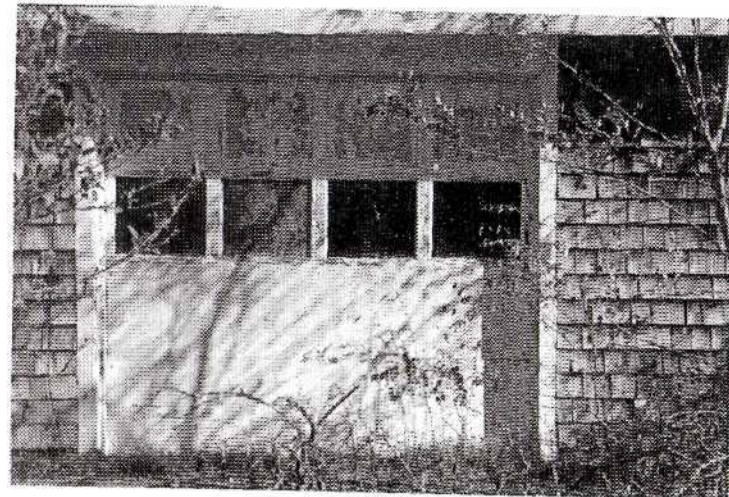
Garage door.

Interior doors include hollow core wood, raised panel, and vinyl bifold, all in **fair/poor condition**. All need to be refinished, but replacement is recommended. All interior doors are 2'-8". Two wood panel doors to exterior in **fair/poor condition**. Garage door in **poor condition**. Replacement of all doors recommended.
